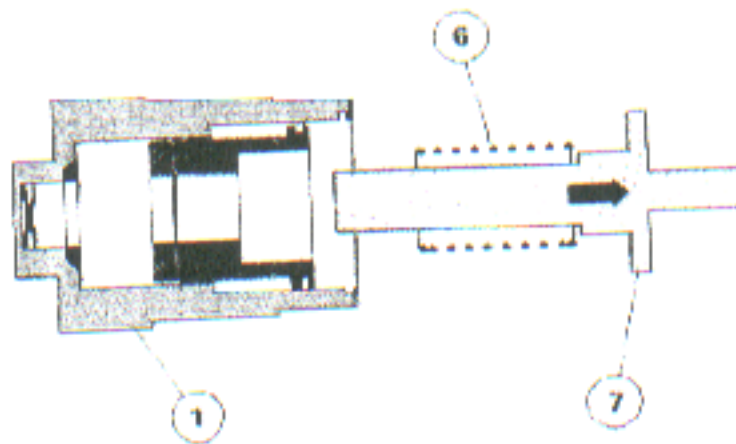
Fig. 3

NOTE The support 7 no longer fits completely into the casing 1, but stops when the rear plane of the flanges projects about 3 mm from the rear end of the casing.

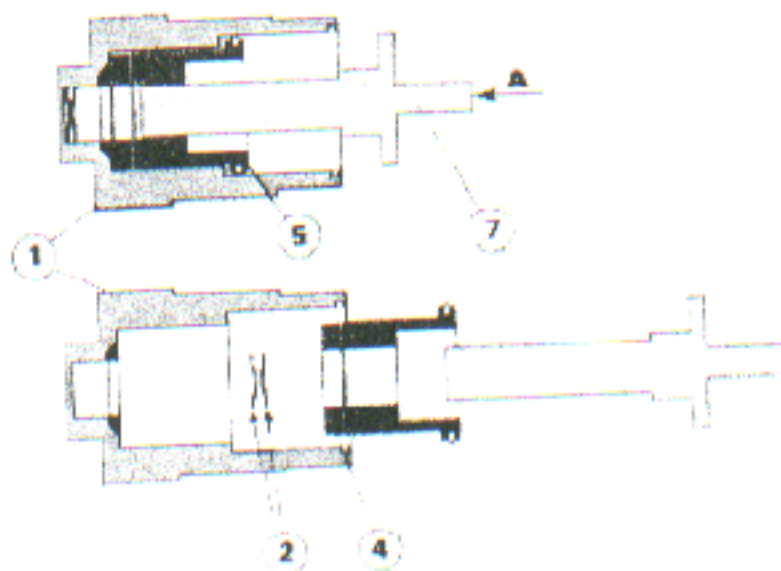
Fig. 4

- Blow through with an air jet (arrow A-Fig. 4) into the centre opening of support 7 until the piston 5 is expelled from the casing 1. Remove the disc 4 and the two thrust springs 2 from the casing 1.
